Design Solution

Vehicle Sales/Service

Don McGill Toyota Houston, TX

60,000 Sq Ft K-13 White

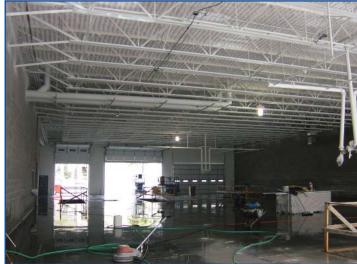
With the 1" application of K-13 on the underside of the roof deck of the service area, an impressive NRC (noise reduction coefficient) of 0.75 was achieved. K-13 creates a pleasurable working environment, by directly reducing the reverberation time.

extremely noisy with the sounds of vehicles coming and going and the machinery used to repair the vehicles. With the concrete floor and high metal roof deck, the acoustics within the facility have become a great concern. K-13 was the perfect choice to control the noice level within the repair center.

The facility also required thermal protection. K-13insulates by creating dead air spaces between and within its hollow fibers. Because K-13 fibers are sprayed-in-place, they fill cracks, seams and voids, forming a monolithic coating over
